IRRIGATION DISTRICT CANAL LINING, CALIFORNIA ITL RCR-7®

PROJECT OVERVIEW

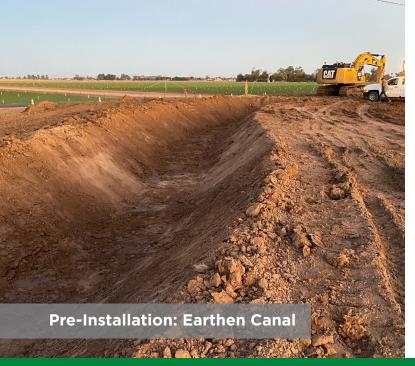
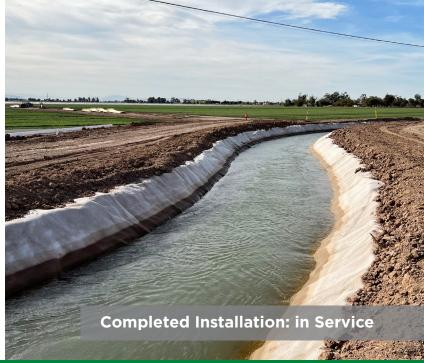
As illustrated, there were some difficult angles to overcome in the transition from the RCR® material to the existing concrete vault. The installation of the material differed from typical application in that it was applied from the upstream side, resulting in extra attention to seam security.
